MONITORING COMPLETED COASTAL PROJECTS: OPERATIONAL ASSESSMENT OF FLOATING BREAKWATERS, PUGET SOUND, WASHINGTON

Eric E. Nelson

J. Michael Hemsley
Coastal Engineering Research Center

April 1988

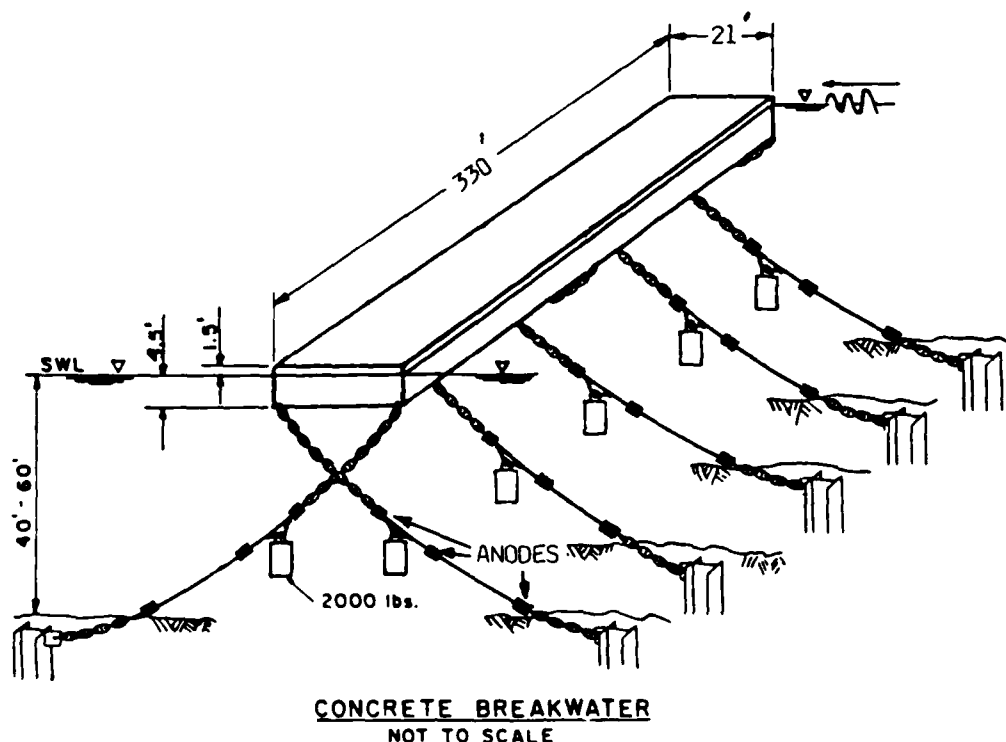
Figure 3. Schematic of breakwater unit and anchor system for Friday Harbor (swl = still-water line)

14. The breakwater consists of five rectangular concrete pontoons, three of which are 330 ft long by 21 ft wide by 6 ft high. Two pontoons are 16 ft wide by 5.5 ft high (Figure 2**). Breakwater anchors are 52 steel H-piles embedded their full length. Anchor lines consist of 1-3/8-in.-diam galvanized bridge rope with 30 ft of 1-1/4-in. stud link chain at the upper end. Anchor line lengths were sized to provide a scope of 4:1 to 5:1. A 2,000-lb concrete clump weight is attached approximately 50 ft from the upper end of each anchor line. Anchor line initial tension is approximately 10,000 lb. Three large aluminum anodes were attached to each anchor line to prevent corrosion (Figure 3).

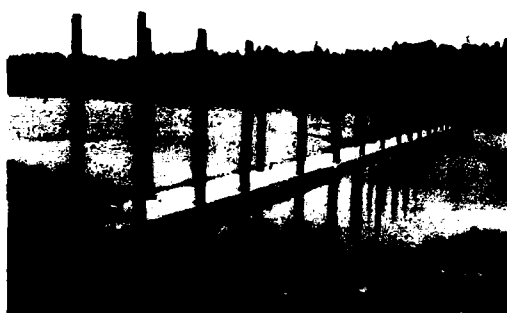
Photo 3. East Bay floating
breakwater

20. The breakwater consists of seven rectangular concrete modules, 100 ft long by 16 ft wide by 5.5 ft deep. Module walls are 5.0 in. thick with welded wire reinforcing, and each module is longitudinally posttensioned. The breakwater is held in place by timber anchor piles driven 20 ft into the medium-dense sands below the bay muds as shown in Photo 3. Modules are connected by large rubber fenders bolted between adjacent units. Dredging was
